FA-TR-76011

A CRITICAL ASSESSMENT OF THE
ALUMINUM CARTRIDGE CASE FAILURE MECHANISM

March 1976

U.S. ARMY ARMAMENT COMMAND
FRANKFORD ARSENAL
PHILADELPHIA, PENNSYLVANIA 19137

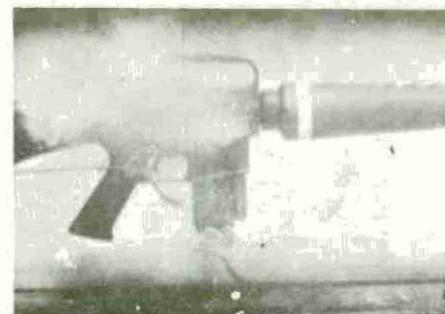
The luminous cloud seems to have propagated out of the field of view in Frame 8 (Figure 10). There is also evidence of solid particles (probably propellant grains) in the bolt cavity of the weapon. The initial blast, observed at the bottom of the magazine, has sufficient force to destroy the magazine; the spring can be seen ejecting from the magazine's body.

Figure 10. High Speed Motion Picture Sequence of Aluminum Cartridge Case "Burn-Through" in M16A1 Rifle (From 6.0 milliseconds to 60 milliseconds.)

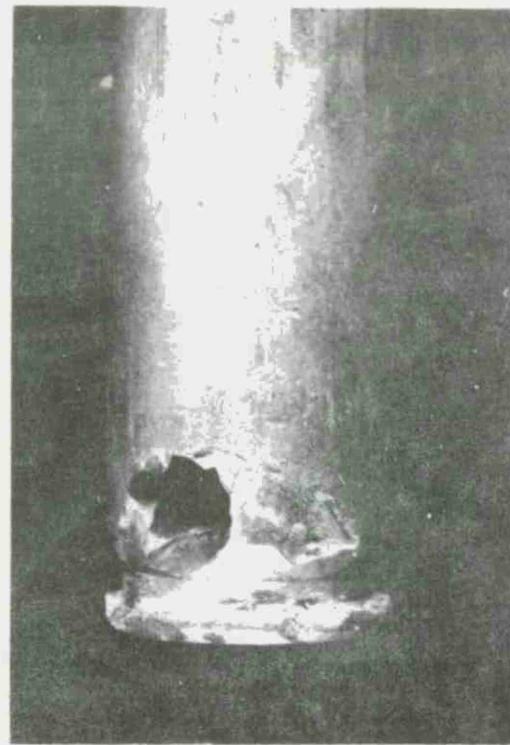
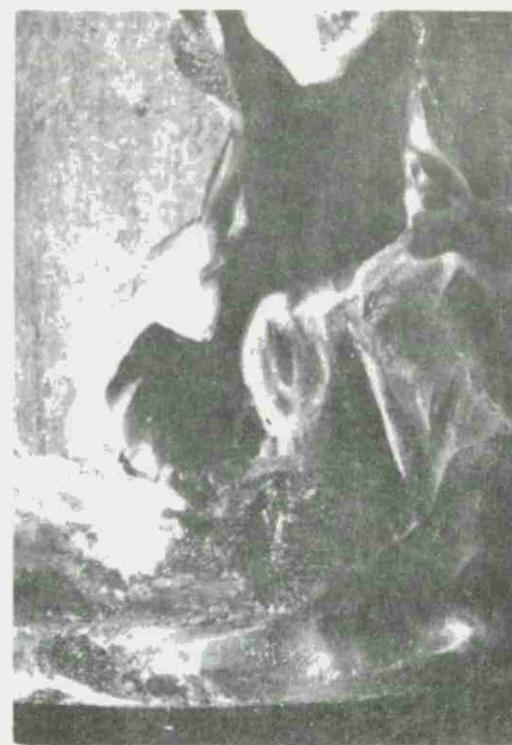
Figure 70. Photomacrographs of "Burn-Through" Areas in 5.56mm Aluminum Cartridge Cases

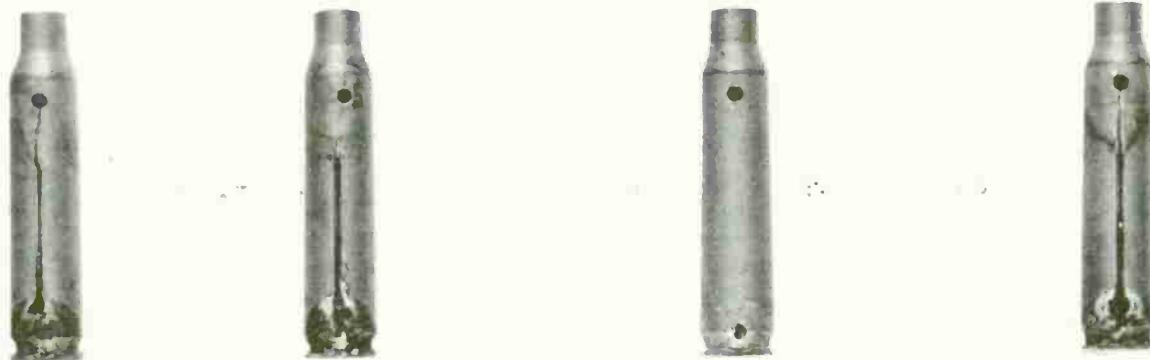
HMX PROPELLANT -- 2100⁰K

100% 20 MESH
0% 35 MESH
CHARGE 22.09 GRAINS

CARTRIDGE CASE
PEAK CHAMBER PRESSURE
PROJECTILE
SPECIMEN

Slit
26,500 psi
Light
1

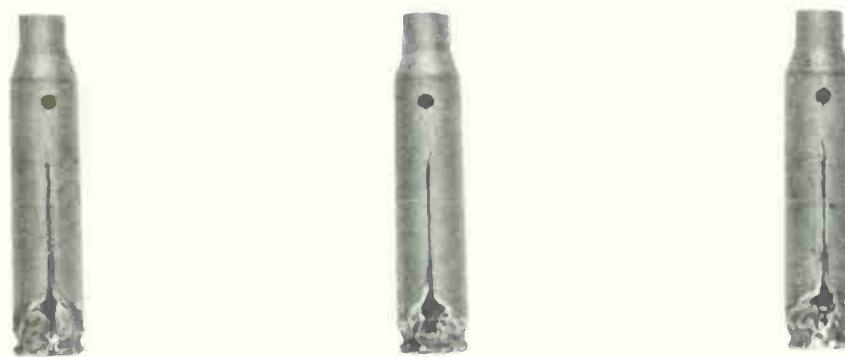
HMX PROPELLANT -- 2300⁰K

100% 20 MESH
0% 35 MESH
CHARGE 23.25 GRAINS

CARTRIDGE CASE
PEAK CHAMBER PRESSURE
PROJECTILE
SPECIMEN

Slit
28,000 psi
Light
1

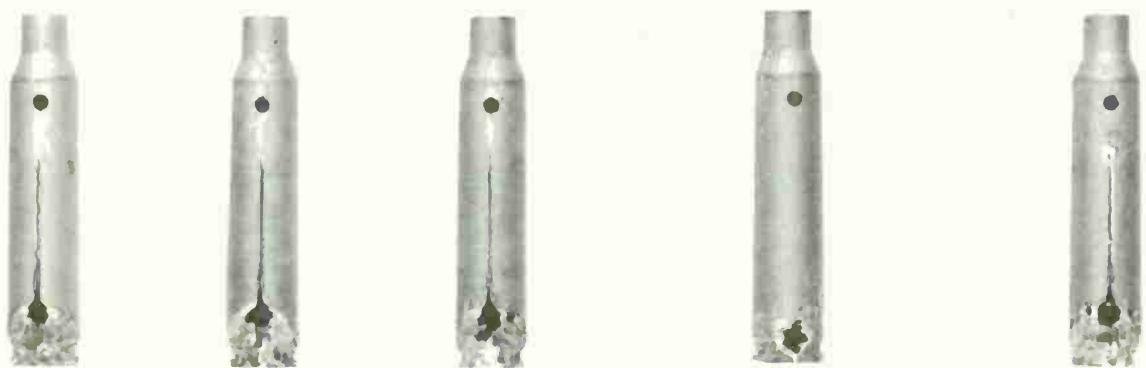
Figure 98. Erosion Characteristics of HMX Propellant 2500^{OK} - Cartridge Cases

100% 20 MESH
0% 35 MESH
CHARGE 23.00 GRAINS

CARTRIDGE CASE	Slit	Slit	Slit	0.031 in (dia) hole	Slit
PEAK CHAMBER PRESSURE	27,500 psi	41,500 psi	43,500 psi	48,000 psi	52,000 psi
PROJECTILE	Light	Heavy	Heavy	Heavy	Heavy
SPECIMEN	1	2	3	4	5
